Survey Report:

Lake Quinsigamond

Quinsigamond State Park

February 1995

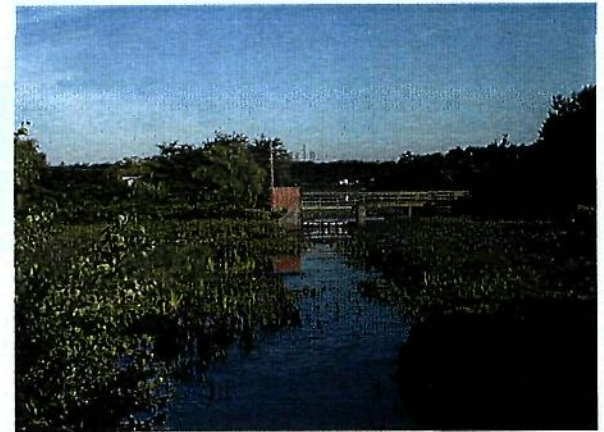
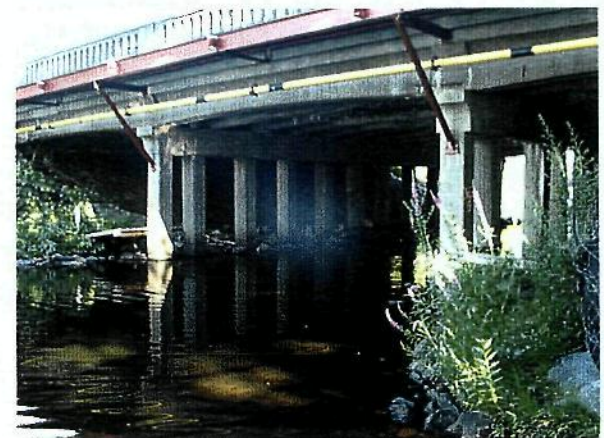
Hydrologic/Hydraulic Design Issues

- **Outflow Control Parameters**
 - Irish Dam
 - Bridge at Creeper Hill Road
 - Bridge at Conrail Tracks
 - Hovey Pond Dam
- **Inflow Control Parameters**
 - Route 20 Bridge (allow for flood passage)
 - Route 20 Culvert (allow for flood passage)
 - Stringer Dam

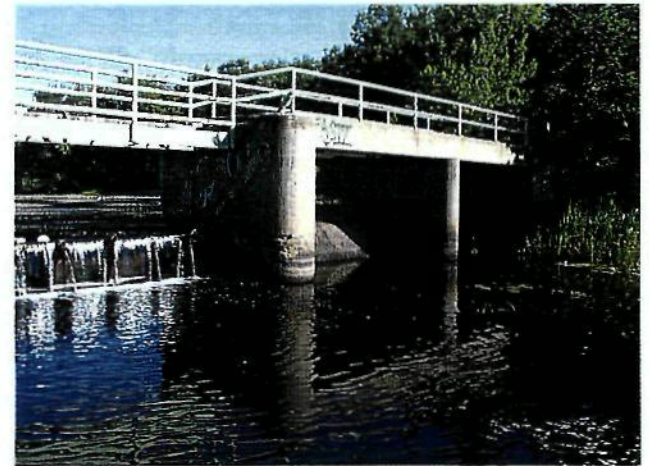
Hydrologic/Hydraulic Design Issues (continued)

- **Hydrologic Modeling**
 - Watershed Delineation and Drainage Patterns
 - HEC-1 Rainfall/Runoff Model
 - Streamflow/Pond Fluctuation Evaluation
- **Hydraulic Control Options**
 - Irish Dam:
 - Notch Spillway
 - Operation of Bascule Gate
 - Other Outflow Modifications
 - Hydraulic Separation of Lake Quinsigamond & Flint Pond (allow for passage of flood waters)
